# **Reserve Report**

Full Reserve Study

## MT Washington Hills Condominium

Baltimore, Maryland

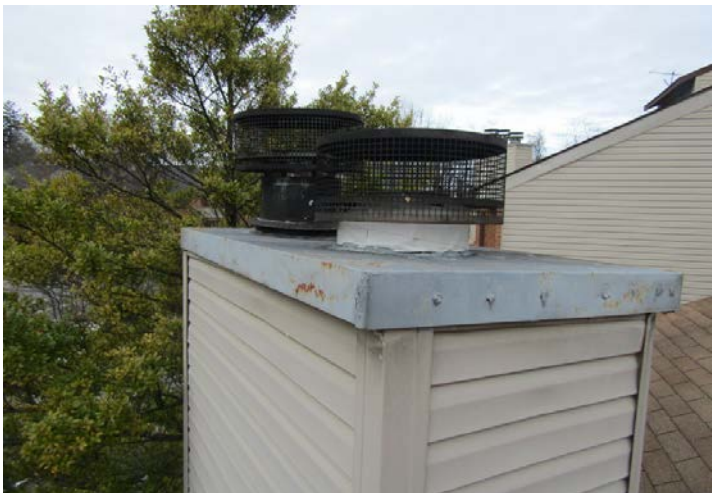
rust at metal

Engineering solutions: The chimney chase covers are near the end of their useful lives. Chimney chase cover replacement should include a cambered top to shed water, a formed drip edge to direct water away from the siding and fasteners through the sides to minimize the potential for leaks.

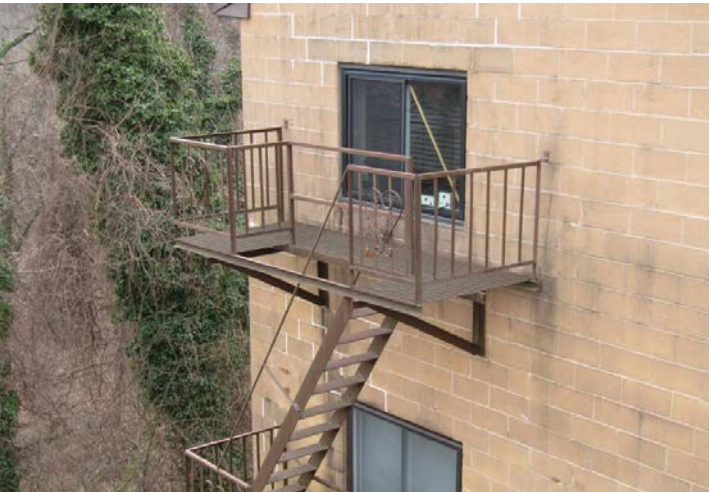
Material:	metal
Overall condition:	fair
Specific condition:	weathering and rust
Quantity (each):	3
Cost (\$/each):	\$12,000
Current total cost:	\$36,000
Cost per home:	\$590
Anticipated expenses:	painting, minor repairs
Operating expenses:	interim touch up painting

fire escape

Engineering solutions: Replacement of the fire escapes is not likely during the next 30 years. Instead, we recommend periodic inspections, repairs and painting.

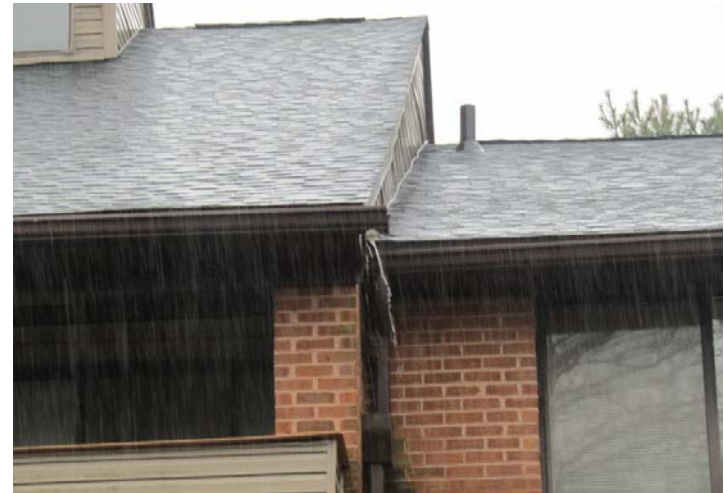
missing downspout at rear of 1704

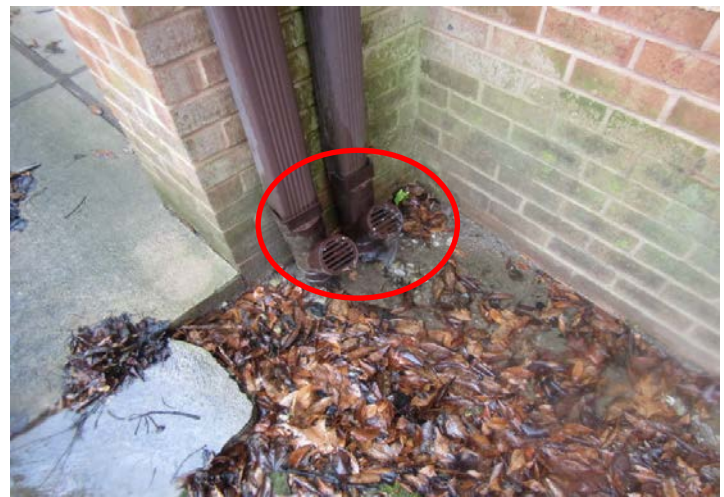
overflowing downspout

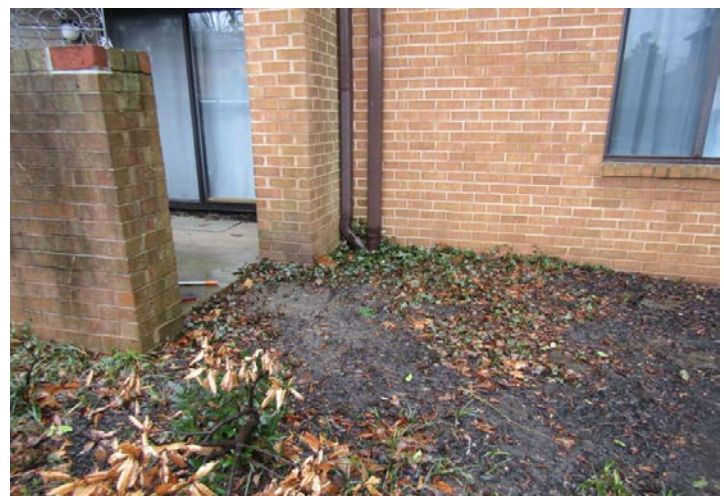
**Actionable recommendations:** We observed leaks into the garage, such as at the storage area K at 1704. This leak is adjacent to two large capacity downspouts that discharge into a smaller capacity, single subterranean pipe. We suspect that either water overflows at this undersized connection and/or the subterranean pipe is clogged. We observed other locations where storm water was flowing out of the clean-outs at the downspouts indicating the subterranean piping is clogged. The property should clean gutters twice a year (after trees lose their seedlings in the spring and their leaves in the fall) to ensure proper flow.

two downspouts at location of leak into garage at 1704

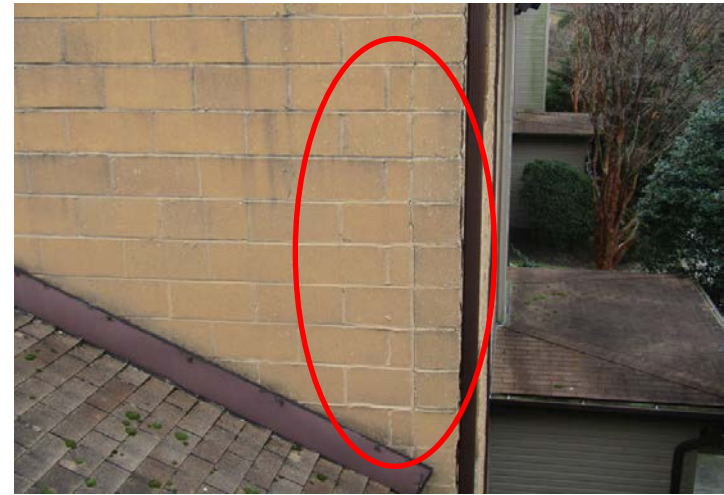
The building exhibits a history of crack repairs due to settlement. It is indeterminate if settlement has stabilized. We recommend the installation of foundation crack gauges to determine if movement is active. The following manufacturer provides these simple devices: <https://www.humboldtmg.com/concrete-crack-monitor-crack-gauge.html>. We assume that installation of foundation piers will be necessary.

cracks in masonry

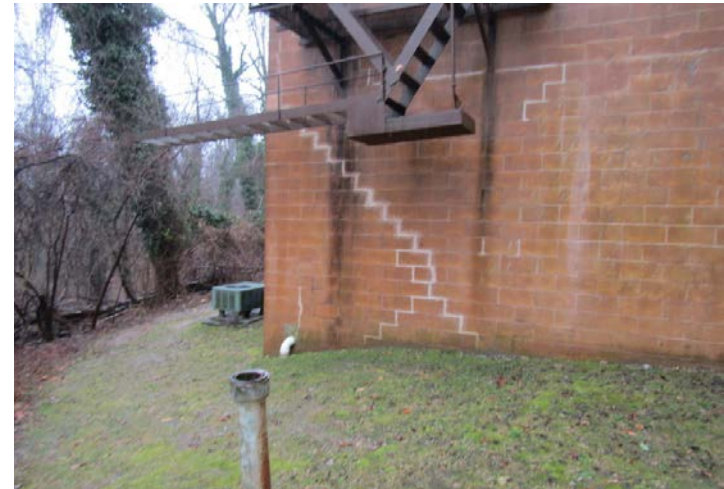
step cracks

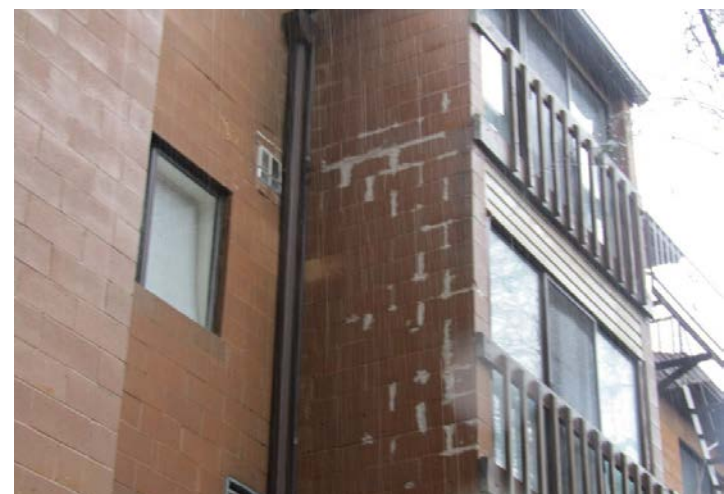
We note the use of caulk to repair mortar joints. Mortar allows any water within the wall to weep out. The application of caulk will trap moisture in the walls and result in accelerated deterioration of the masonry. The property should remove the caulk and repair any deteriorated joints with mortar.

joints repaired with caulk

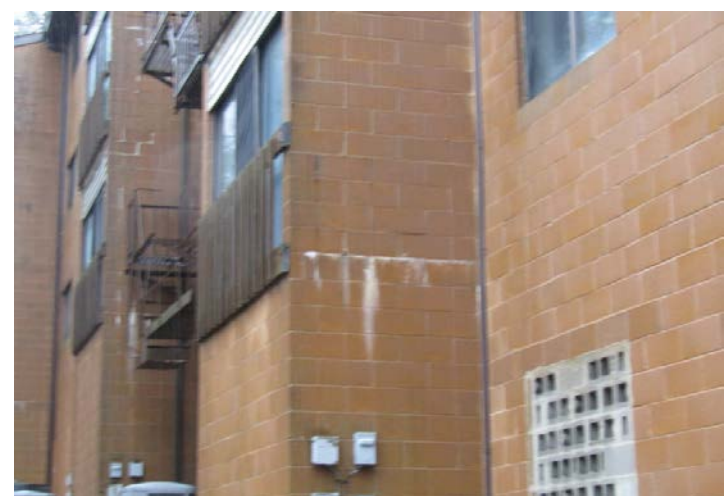
(note 2) White, powdery deposit of soluble salts carried to the surface of masonry by moisture. The moisture evaporates, leaving the residue.

efflorescence

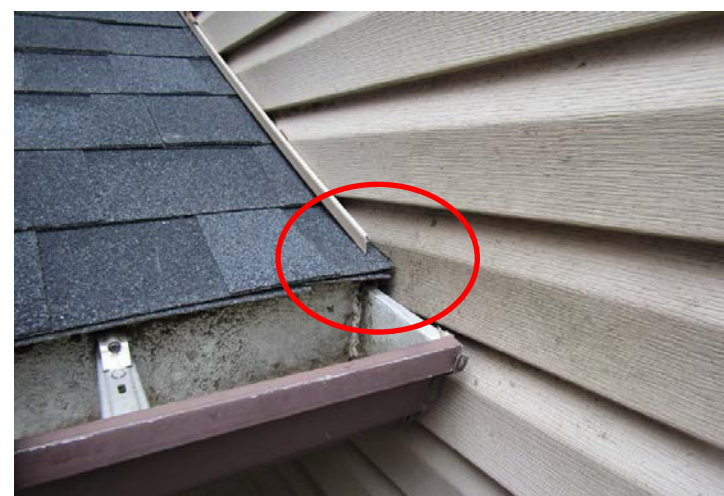
- Kick-out flashing is missing where roofs terminate at gutters adjacent to siding. Water flowing at the roof to wall intersections can bypass the gutters, penetrate the walls and increase the potential for water infiltration. Kick-out flashing should be installed at these locations, integrated with the shingles and step flashing.

missing kick-out flashing at roof, siding and gutter intersection

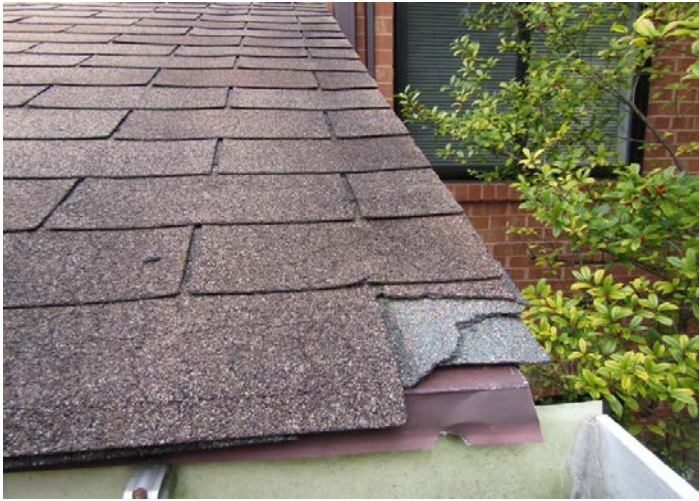
damaged shingles

The property has replaced the roofs at 1702-04. The remaining roofs are at the end of their useful lives and require near term replacement. The following details should be considered when replacing the roofs:

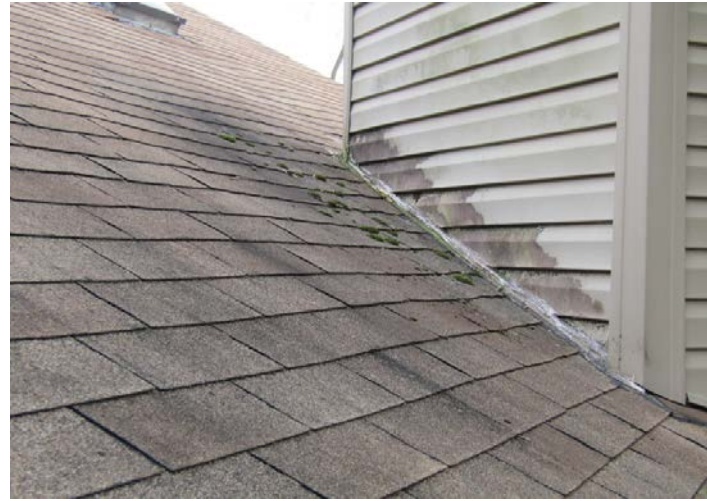
weathered shingles

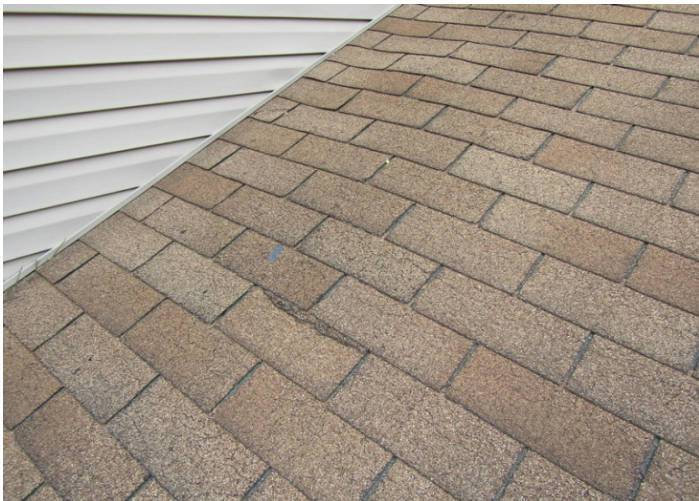
damaged shingles

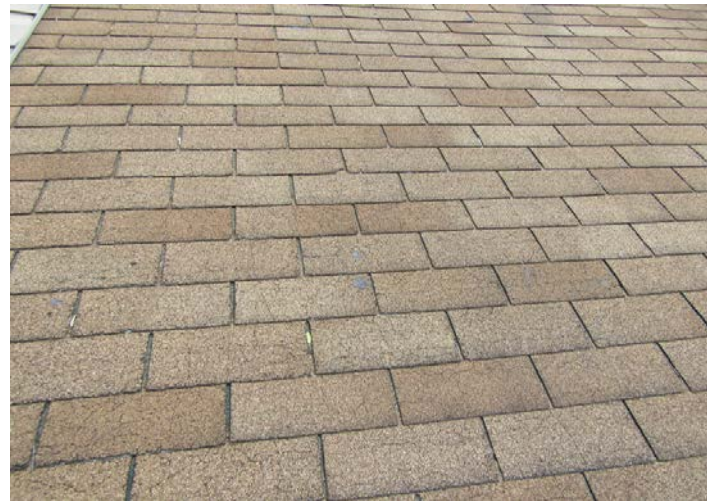
granule loss

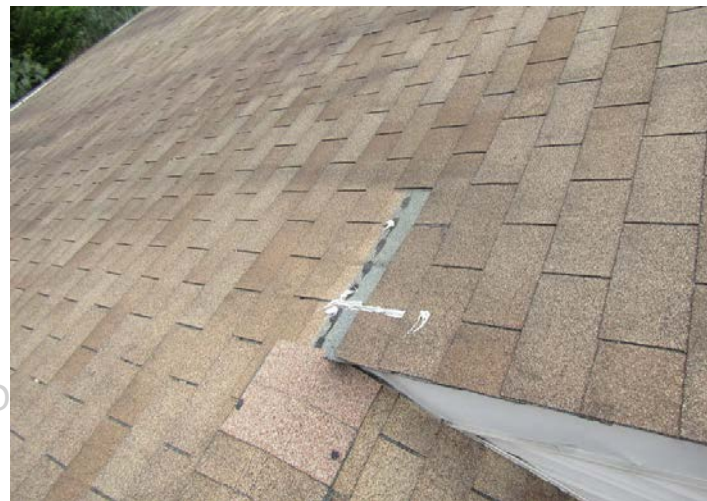
missing shingle

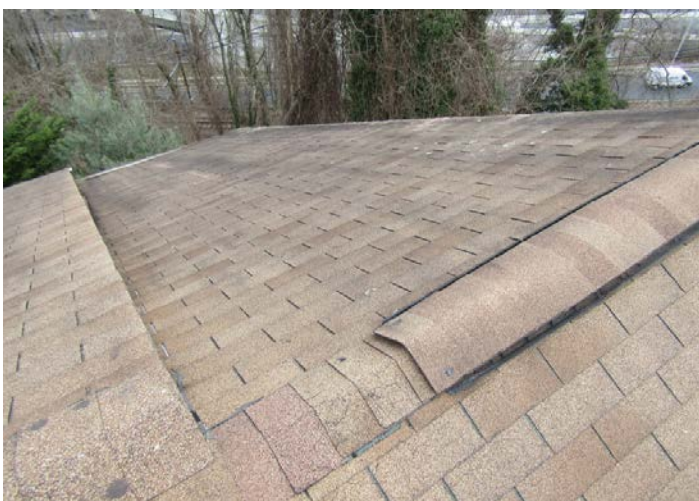
weathered shingles

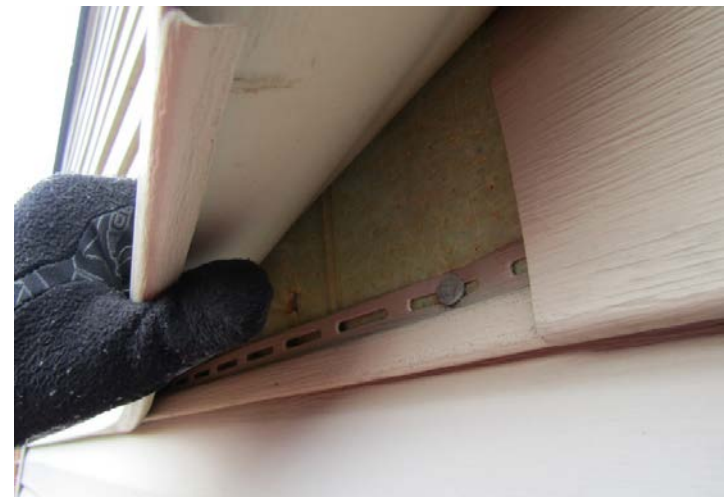
(note 2) Siding is an exterior cladding that is not watertight. Water-vapor permeable building paper is necessary to prevent water from contacting sheathing and interior finishes. Lack of building paper will result in water penetration and deterioration of building substrate.

installation missing building paper

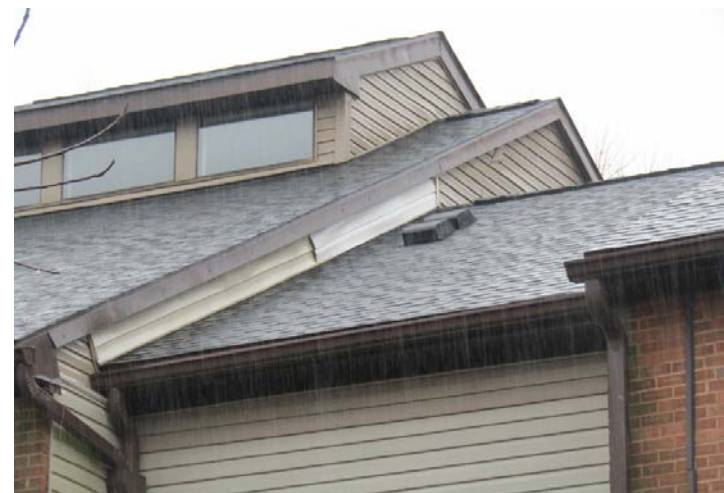
unmatched replacement pieces

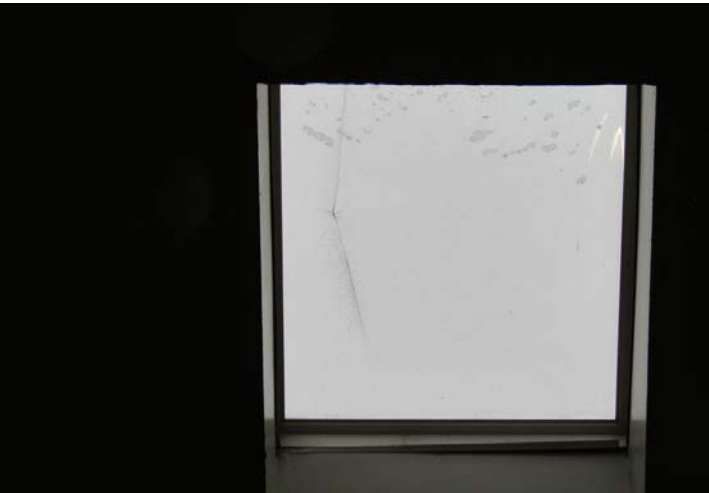
cracked glass

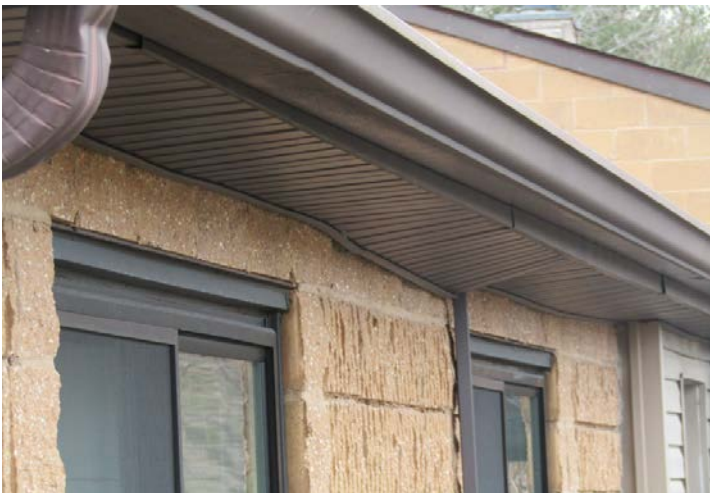
loose soffit

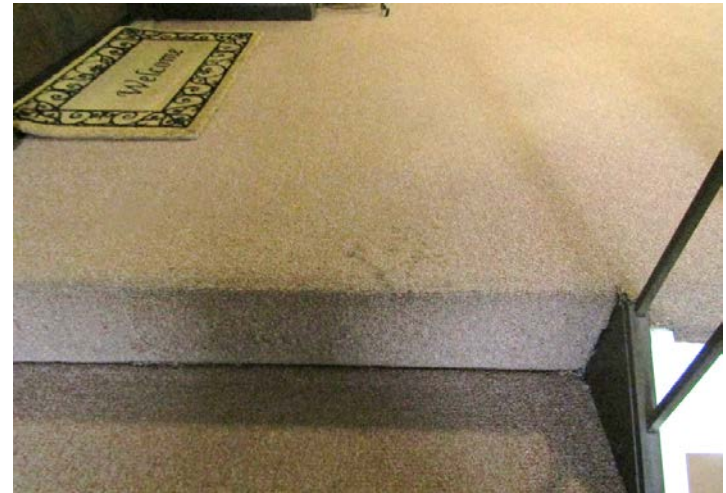
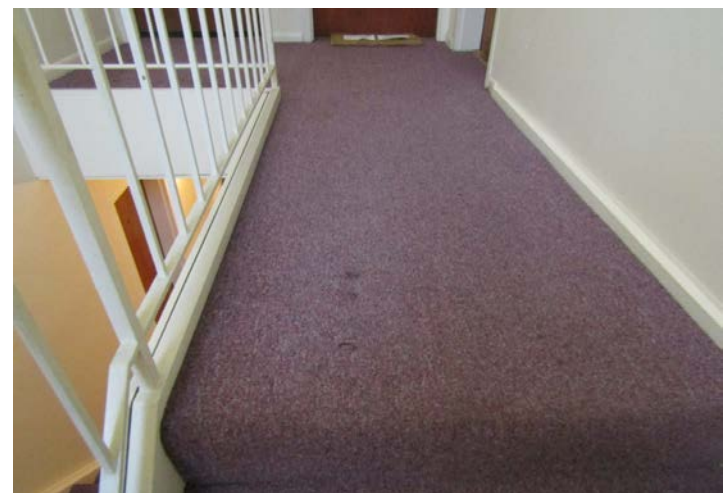
stains

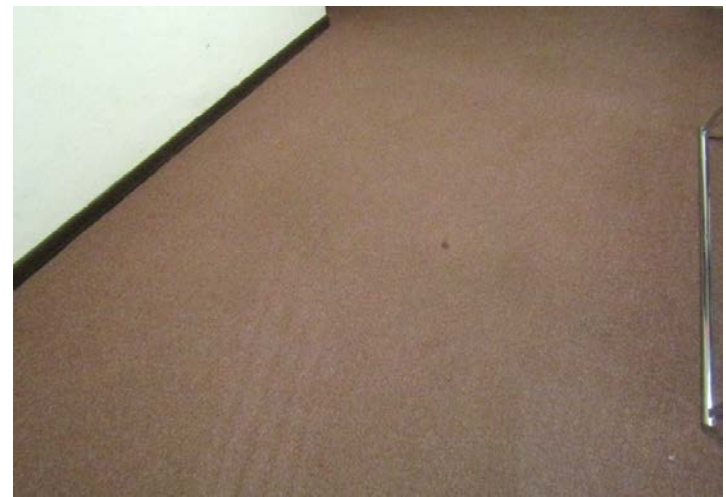
wear

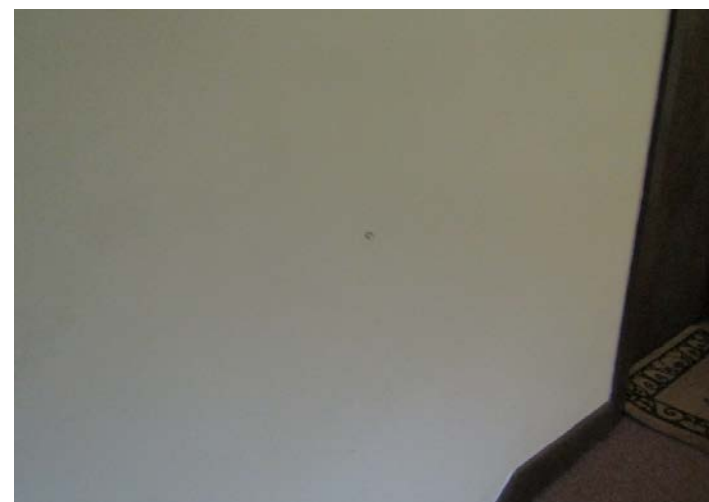
Minor damage

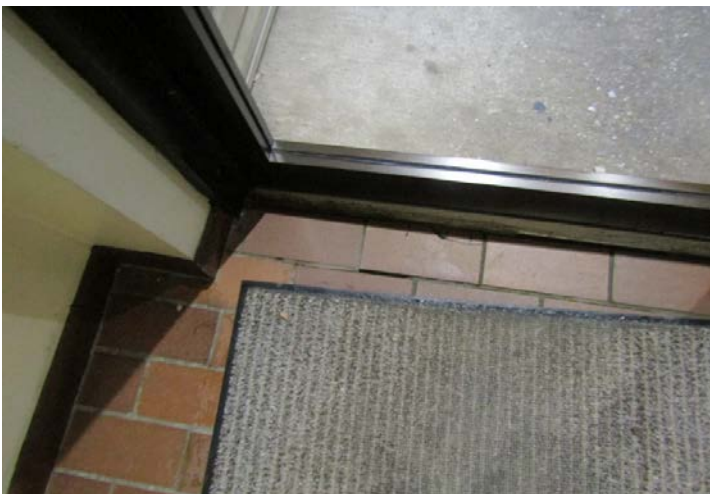
grout damage

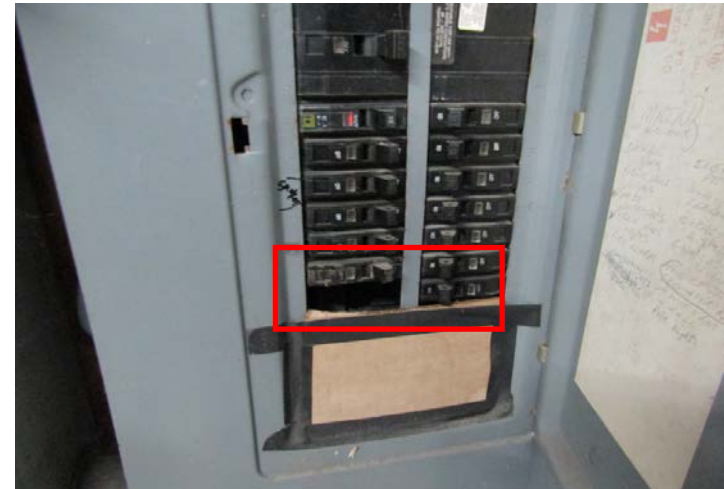
Knock-outs have been removed in the circuit breaker panels. This is a safety hazard. Near term repairs are necessary.

missing knock-outs

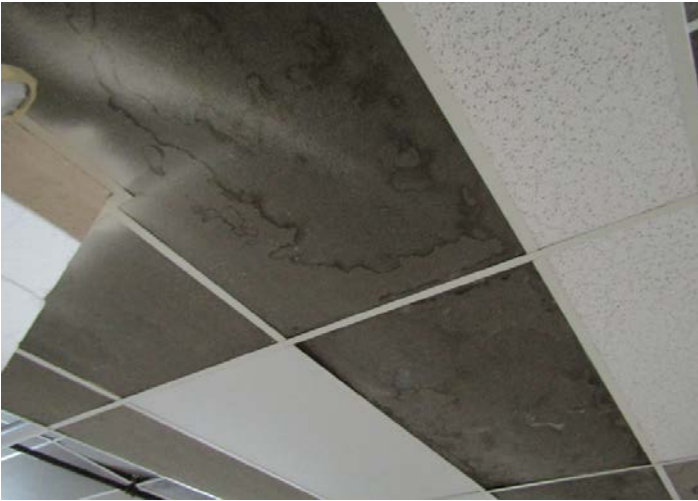
stains

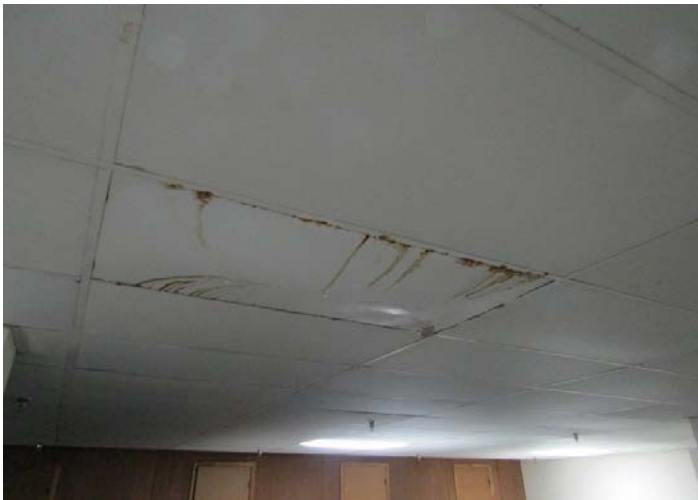
water damage

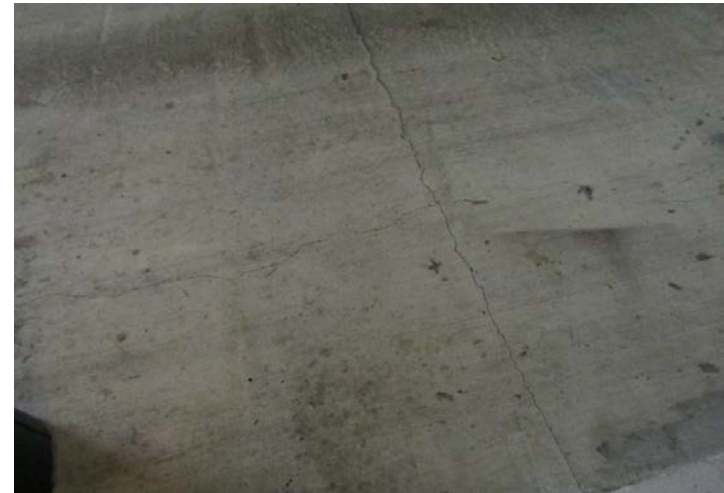
minor cracks

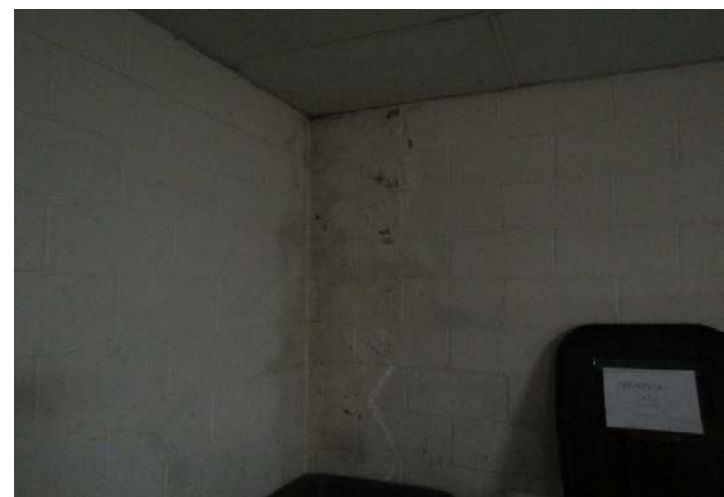
wall leaks

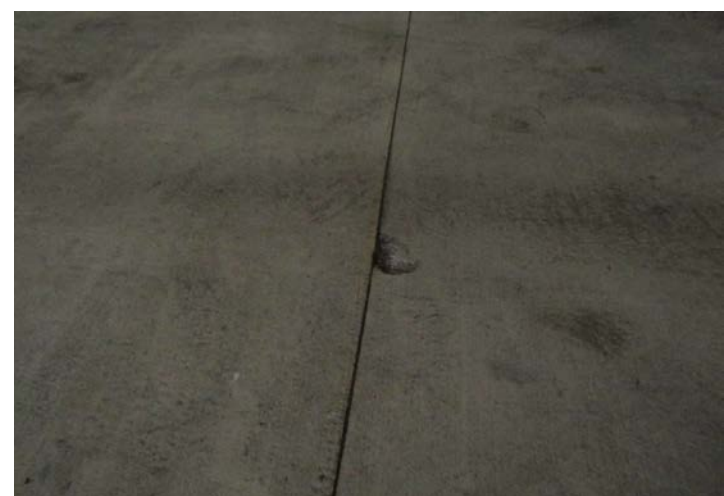
minor damage

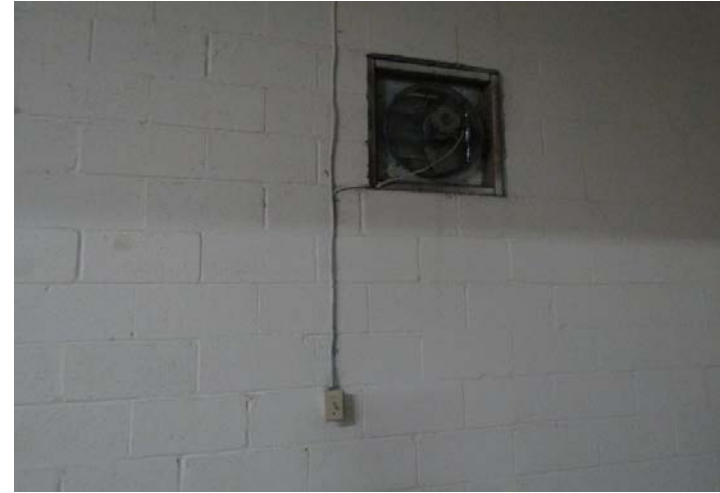
Dayton wall mounted exhaust fan (notice switch in "off" position)

Green ideas: The garage exhaust system serving 1702-04 works off of switches rather than timed intervals (better) or carbon monoxide detectors (best). The switches for the fans were in the "off" position resulting in a safety hazard. The other buildings do not have an exhaust system (likely because they were built earlier and it was not a code requirement) but instead have voids in the block walls that allow for the free exchange of indoor and outdoor air. Portions of these voids have intentionally been blocked, also resulting in a safety hazard. At a minimum, the property should install timers for the operation of the fans and unblock the voids. The property should also consider carbon monoxide detectors to operate the exhaust fans based on the condition of the air rather than timed intervals. This maximizes the quality of the air and minimizes energy consumption.

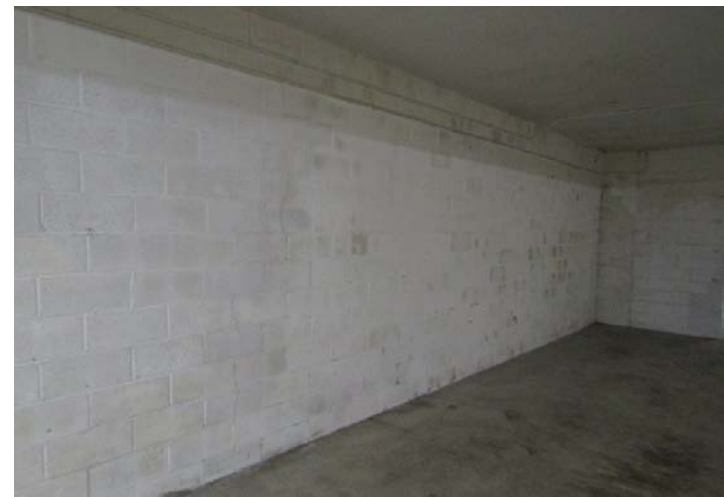
finish deterioration

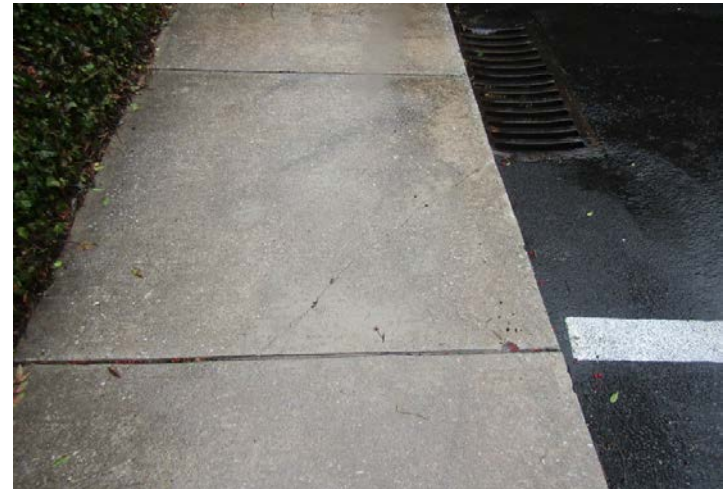
cracked concrete

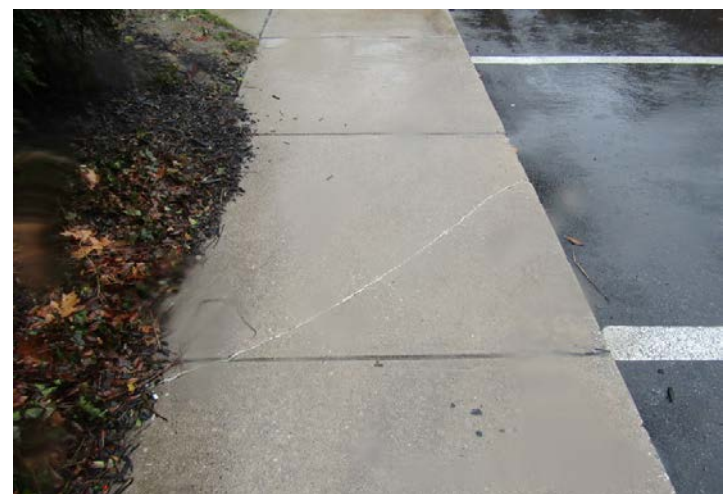
crack in concrete
