# **Reserve Report**

Full Reserve Study

## MT Washington Hills Condominium

Baltimore, Maryland

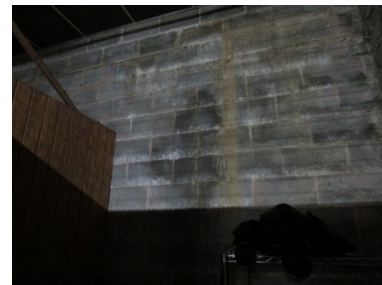
We observed leaks into the garage, such as at the storage area K at 1704. This leak is adjacent to two large capacity downspouts that discharge into a smaller capacity, single subterranean pipe. We suspect that either water overflows at this undersized connection and/or the subterranean pipe is clogged. We observed other locations where storm water was flowing out of the clean-outs at the downspouts indicating the subterranean piping is clogged. The property should clean gutters twice a year (after trees lose their seedlings in the spring and their leaves in the fall) to ensure proper flow.

Figure 1: leak at storage area K of 1704

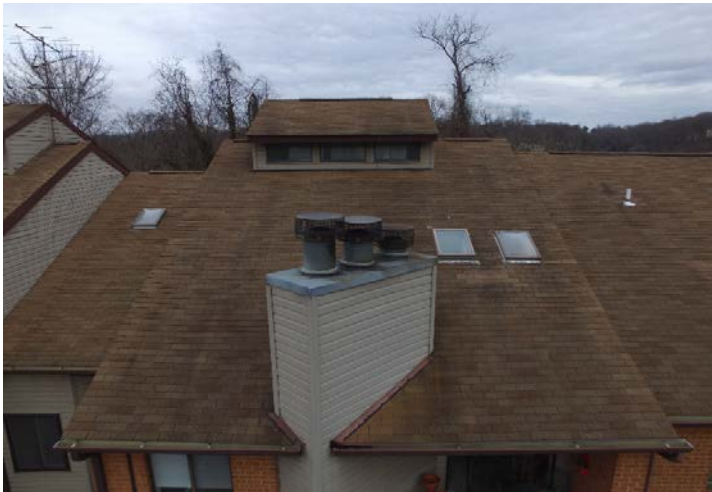
galvanized steel chimney chase cover

Engineering solutions: The chimney chase covers are near the end of their useful lives. Chimney chase cover replacement should include a cambered top to shed water, a formed drip edge to direct water away from the siding and fasteners through the sides to minimize the potential for leaks.

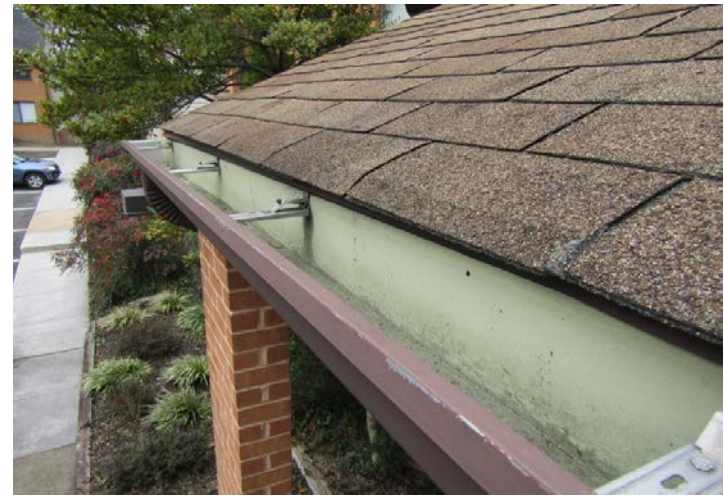
gutters attached with screws

**Actionable recommendations:** We observed leaks into the garage, such as at the storage area K at 1704. This leak is adjacent to two large capacity downspouts that discharge into a smaller capacity, single subterranean pipe. We suspect that either water overflows at this undersized connection and/or the subterranean pipe is clogged. We observed other locations where storm water was flowing out of the clean-outs at the downspouts indicating the subterranean piping is clogged. The property should clean gutters twice a year (after trees lose their seedlings in the spring and their leaves in the fall) to ensure proper flow.

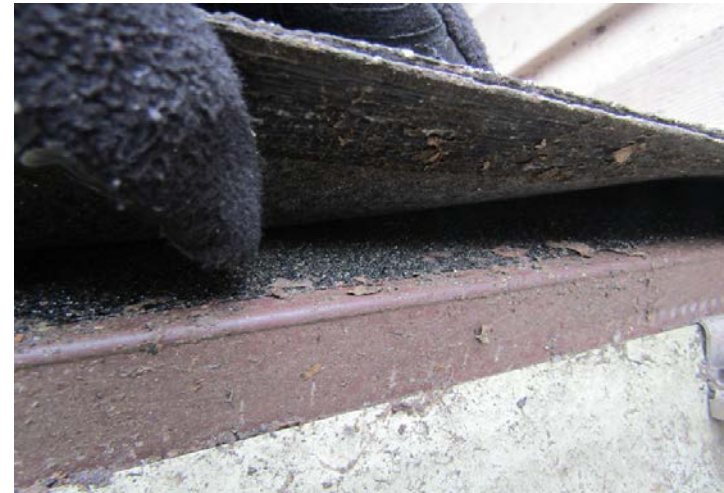
self adhering underlayment at gutter edge

- Use self-adhering underlayment at roof gutter edges and valleys (this was done at the replaced roofs).
- Install metal W valley flashing (rather than weaved shingles) to maximize the useful life of shingles in valleys.

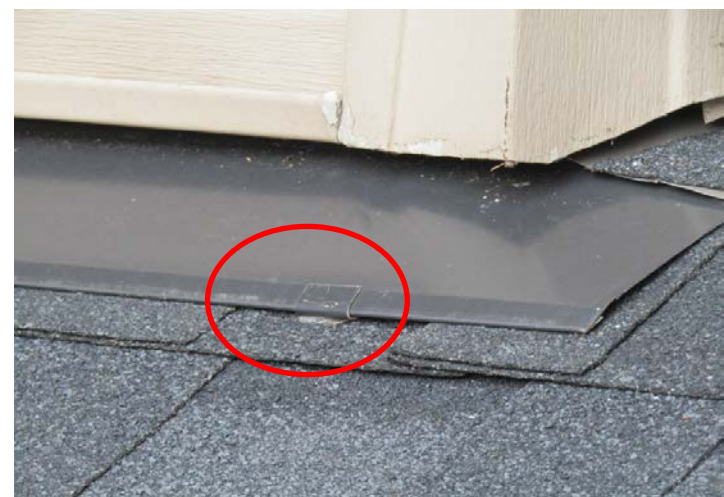
The recently replaced roofs use clips to secure the flashing at roof to wall intersections. This is a very nice detail as it eliminates exposed fasteners and minimizes the potential for leaks.

clip holds flashing - very nice detail at new roofs

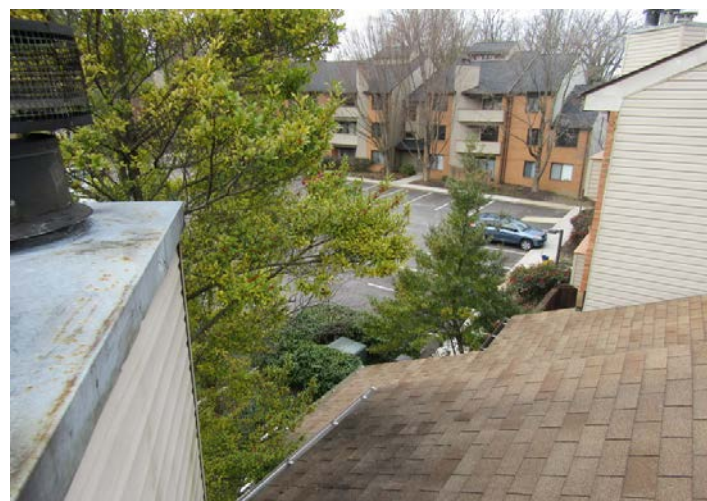
We observed trees overgrowing the roofs. The property should trim back trees to prevent damage from branches rubbing on the roofs and damaging the shingles.

trees overgrowing roof

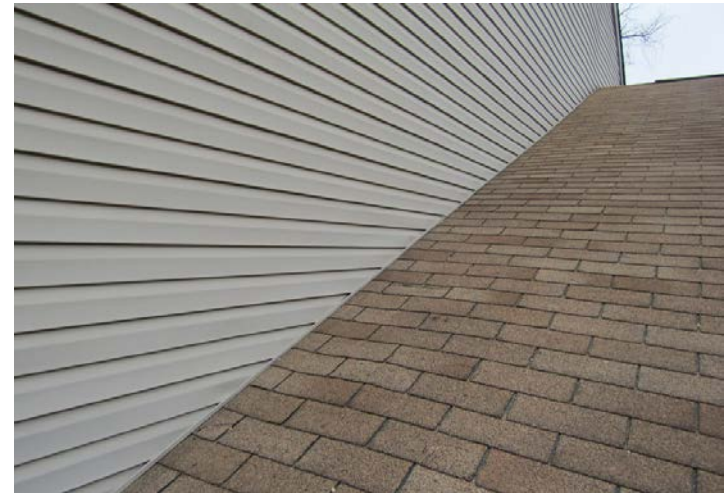
(note 3) The siding throughout the property is in direct contact with the roof. This condition impedes drainage and makes replacement of the shingles more difficult. The Vinyl Siding Institute recommends a 1/2" gap at these locations. It is our opinion that repairs to these conditions are not necessary at this time. Future repairs and replacement should following the guidelines set by the Vinyl Siding Institute: <http://www.vinylsiding.org>

siding in contact with the roof

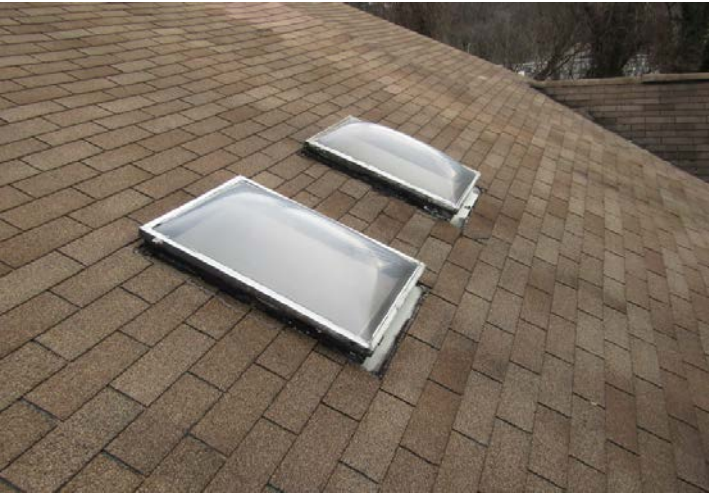
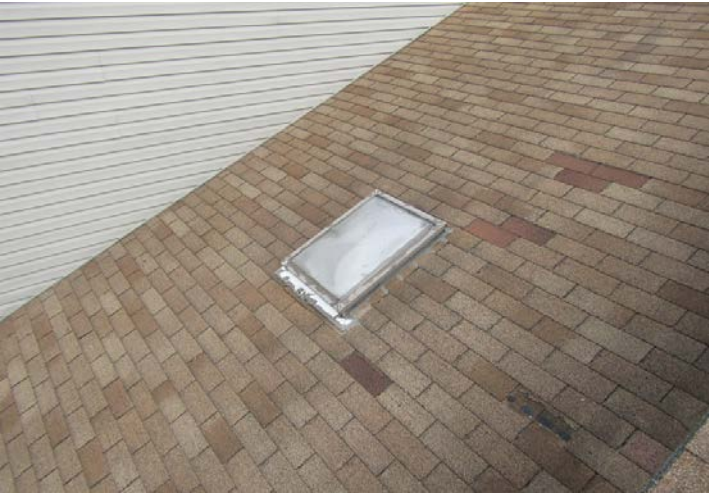
Overall condition:	new to poor
Specific condition:	newer skylights, older skylights and cracked glass
Quantity (each):	12
Cost each:	\$800
Current total cost:	\$9,600
Cost per home:	\$157

older skylights

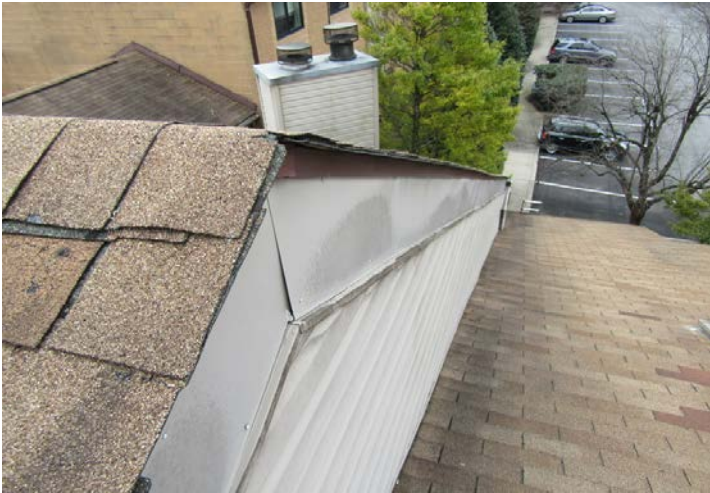
fascia

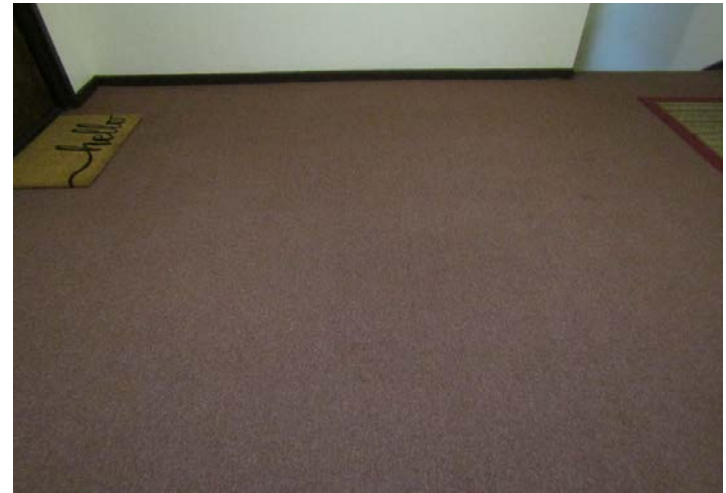
<b>Locations:</b>	hallways and front stairs
<b>Description:</b>	broadloom loop pile carpet
<b>Patterned layout:</b>	no
<b>Carpet pad:</b>	no
<b>Overall condition:</b>	fair
<b>Specific condition:</b>	stains, wear and frays
<b>Quantity (square yards):</b>	400
<b>Per home (square yards):</b>	7
<b>Cost (\$/square yard):</b>	\$45
<b>Current total cost:</b>	<b>\$18,000</b>
<b>Cost per home:</b>	\$295
<b>Operating expenses:</b>	vacuuming, spot removal and periodic cleanings
<b>Assumptions:</b>	medium traffic weight nylon carpet with 36 ounces of fiber per square yard

broadloom loop pile carpet

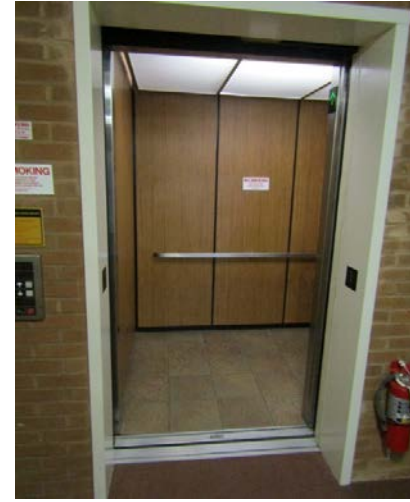
elevator cab finishes

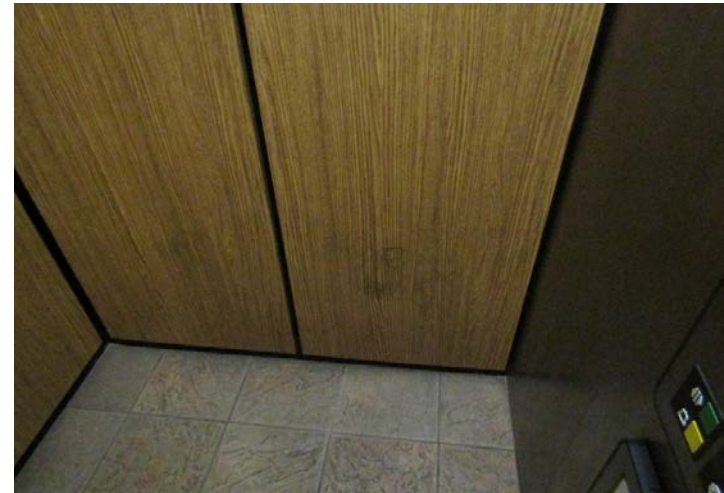
<b>Materials:</b>	tile flooring laminate walls acrylic ceiling
<b>Overall condition:</b>	fair
<b>Specific condition:</b>	scuffs
<b>Average light level (lux):</b>	80 (200 is ideal)
<b>Quantity (each):</b>	3
<b>Cost (\$/each):</b>	\$13,000
<b>Current total cost:</b>	<b>\$39,000</b>
<b>Cost per home:</b>	\$639
<b>Operating expenses:</b>	interim replacements, refinishing of hardware and metal surfaces

scuffs

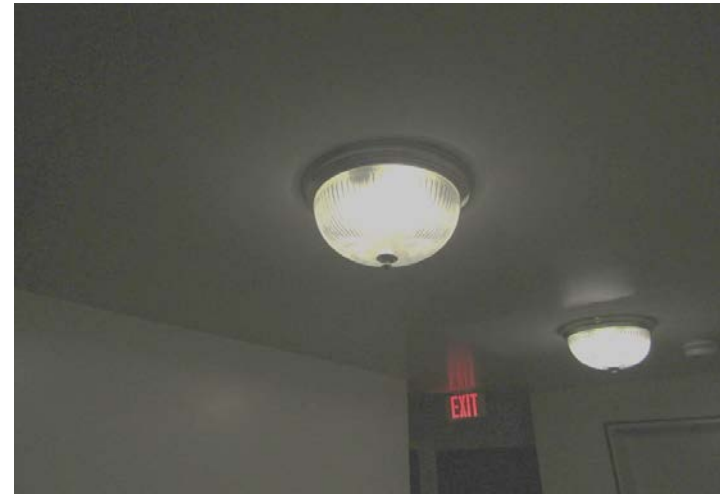
<b>Locations:</b>	hallways, front stairs and foyers
<b>Mounted on:</b>	wall and ceiling
<b>Bulb type:</b>	fluorescent
<b>Overall condition:</b>	satisfactory
<b>Average light level (lux):</b>	50 (200 is ideal)
<b>Quantity (each):</b>	30
<b>Cost (\$ each):</b>	\$160
<b>Current total cost:</b>	<b>\$4,800</b>
<b>Cost per home:</b>	\$79
<b>Assumptions:</b>	reuse of existing wiring
<b>Operating expenses:</b>	bulb replacement

typical lighting

**Actionable recommendations:** The light output in the hallways is low. For safety reasons, the property should consider increasing the lighting levels by installing higher output bulbs (verify the fixtures are designed appropriately). See <https://www.gsa.gov/node/82715> for a recommendation of appropriate lighting levels.

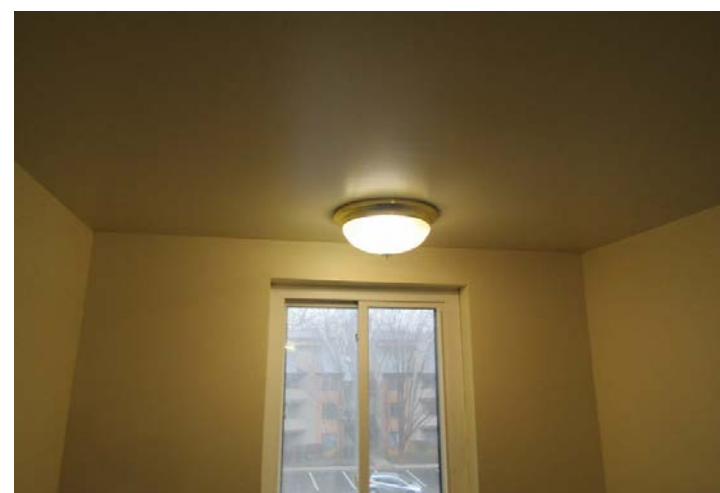
light operating during daylight

**Green ideas:** The hallway lights operate even when daylight is available. The property should install daylight controls, which automatically shut off lights when enough ambient light exists, to maximize daylight use, minimize electrical use while still maintaining lighting level requirements (potential savings of up to approximately 50% annually). A less costly option is to install light bulbs with daylight sensors: <https://www.amazon.com/Photosensor-Detection-Outdoor-Lighting-630Lumens/dp/B01LW4JUW2>.

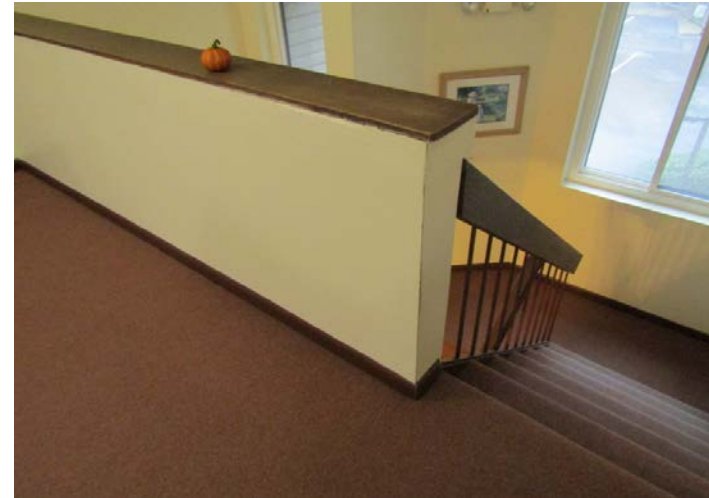
<b>Locations:</b>	hallways, front stairs and foyers
<b>Surfaces:</b>	walls, ceilings and door frames
<b>Color scheme:</b>	single tone
<b>Overall condition:</b>	fair
<b>Specific condition:</b>	scuffs and minor damage
<b>Quantity (square feet):</b>	16,000
<b>Per home (square feet):</b>	260
<b>Cost (\$/square foot):</b>	\$1.00
<b>Current total cost:</b>	<b>\$16,000</b>
<b>Cost per home:</b>	\$262
<b>Operating expenses:</b>	interim paint touch ups and wall repairs
<b>Assumptions:</b>	two coats of paint

Minor scuffs

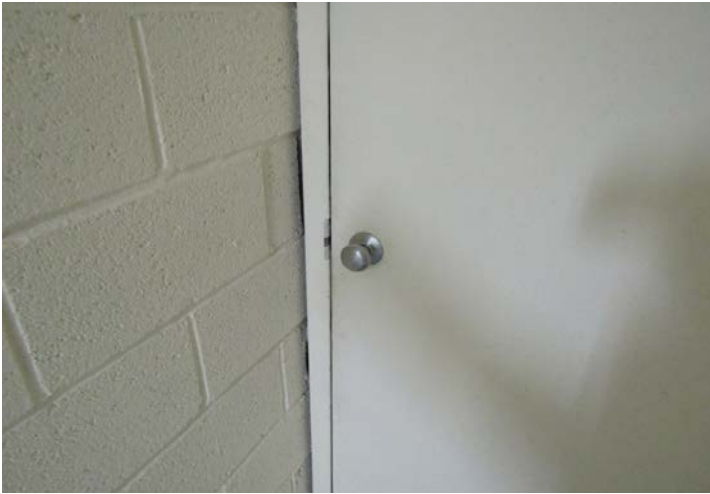
door knob rather than handle

Actionable recommendations: Door handles are easier to operate than the existing stairwell door knobs. This could be a potential concern in an emergency situation. The property should consider replacing all stairwell door knobs with handles and fund this expense through the operating budget. The following website provides additional information: <http://www.ada-compliance.com/ada-compliance/ada-doors.html>

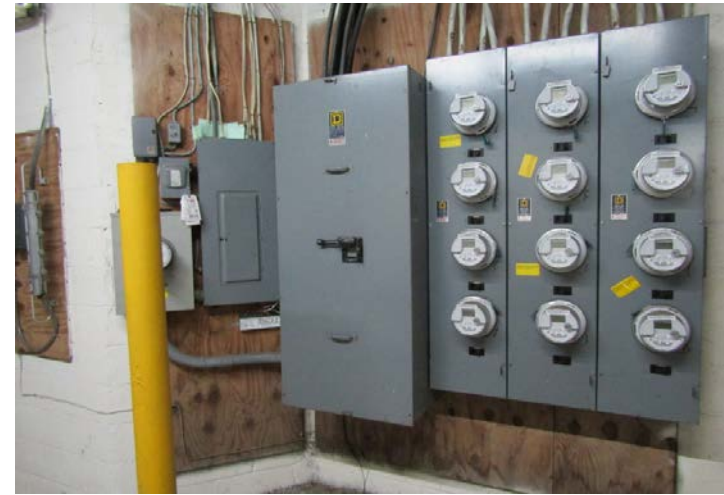
Actionable recommendations: Knock-outs have been removed in the circuit breaker panels. This is a safety hazard. Near term repairs are necessary.

electric panel

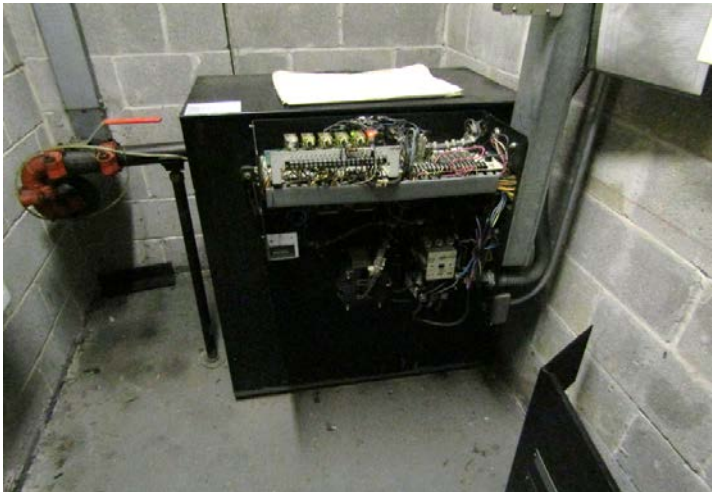
relay logic controls

Actionable recommendations: The elevator equipment rooms do not have exhaust fans. Excessive heat can cause the elevator equipment to malfunction. The property should monitor the temperature in the elevator equipment rooms during the summer and determine if it is necessary to install exhaust fans with thermostats.

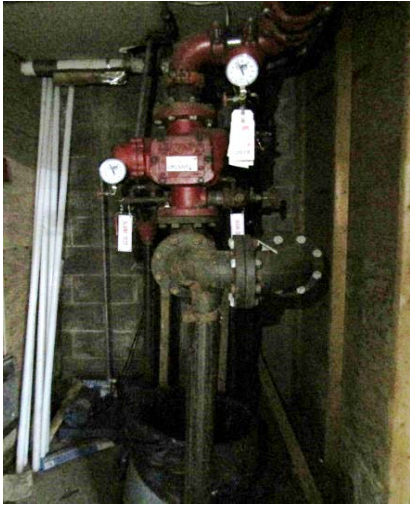
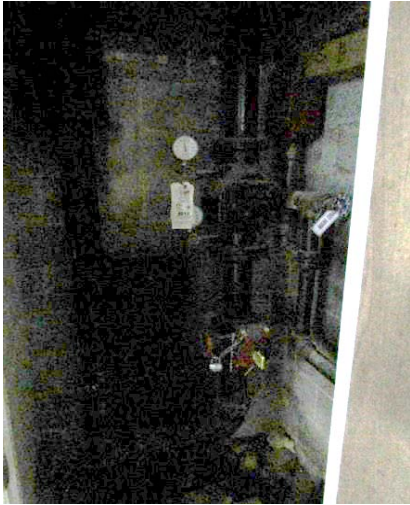
Assemblies (each):	2
Serving:	incoming water, fire suppression system
Operational condition:	satisfactory
Physical condition:	history of leaks
Average cost per valve:	\$16,500
Current total cost:	\$33,000
Cost per home:	\$541
Operating expenses:	replacement of valves less than 4" in diameter

valves

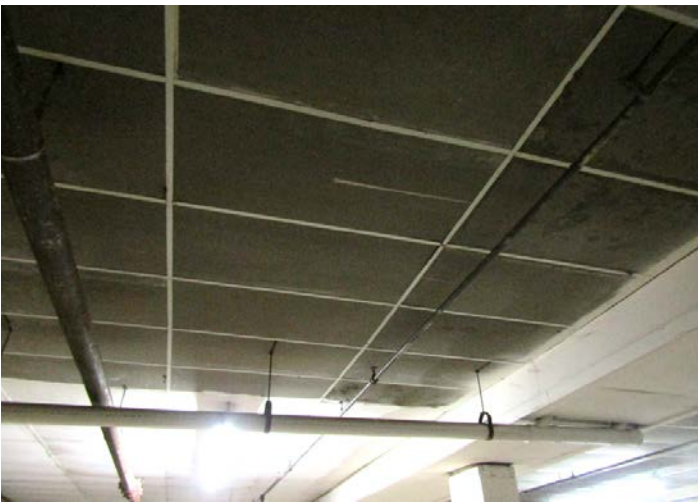
Location:	garages
Tile size:	two-foot by four-foot
Overall condition:	fair to poor
Specific condition:	stains and damage
Quantity (square feet):	14,500
Cost (\$/square foot):	\$3.90
Current total cost:	\$56,600
Cost per home:	\$928
Operating expenses:	interim replacements of damaged tiles
Assumptions:	5/8 inch thick fiberglass ceiling board

two-foot by four-foot ceiling tile and grid typical of the garages

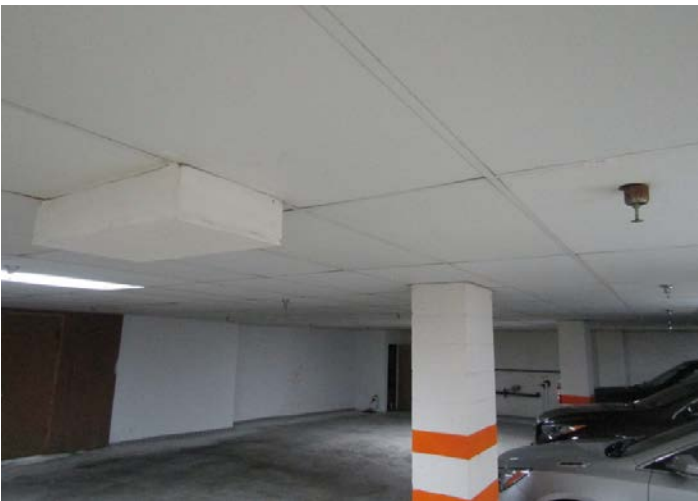
ceiling tiles

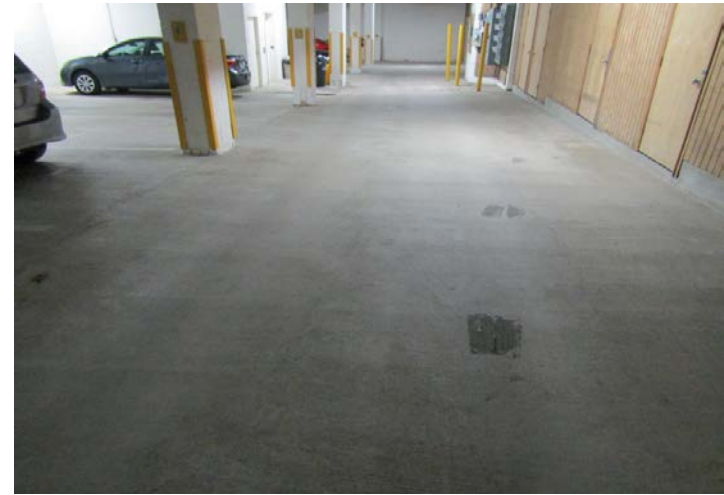
<b>Floor type:</b>	on-grade concrete
<b>Overall condition:</b>	good to fair
<b>Specific condition:</b>	minor cracks, wear, damage and wall leaks
<b>Floor area (square feet):</b>	21,000
<b>Current total cost (note 1):</b>	<b>\$13,000</b>
<b>Cost per home:</b>	\$213
<b>Operating expenses:</b>	sealer application (only if desired), interim repairs, cleaning
<b>Anticipated expenses:</b>	concrete crack repairs replace on-grade concrete (1%) epoxy injection of wall leaks stripe parking areas

on-grade concrete

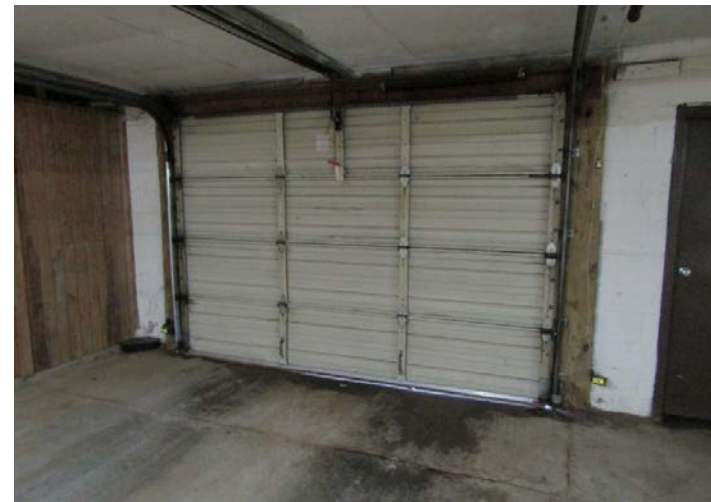
metal panel garage door

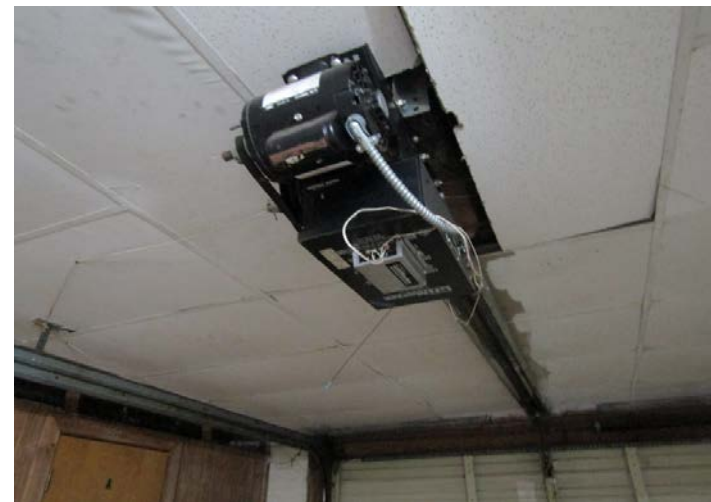
LiftMaster door operator

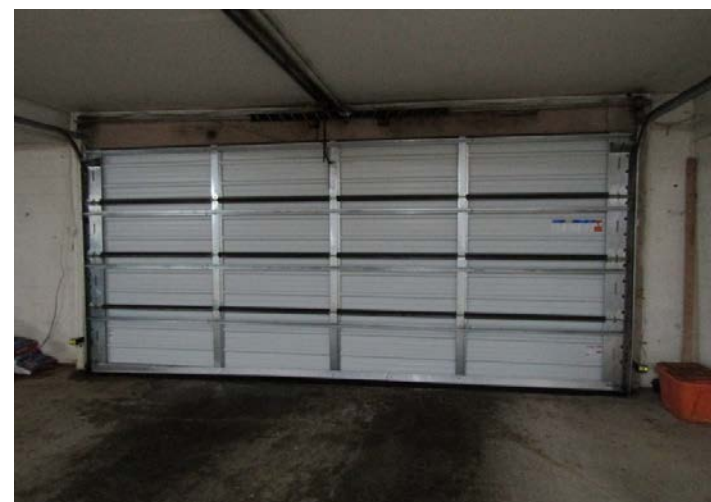
garage door

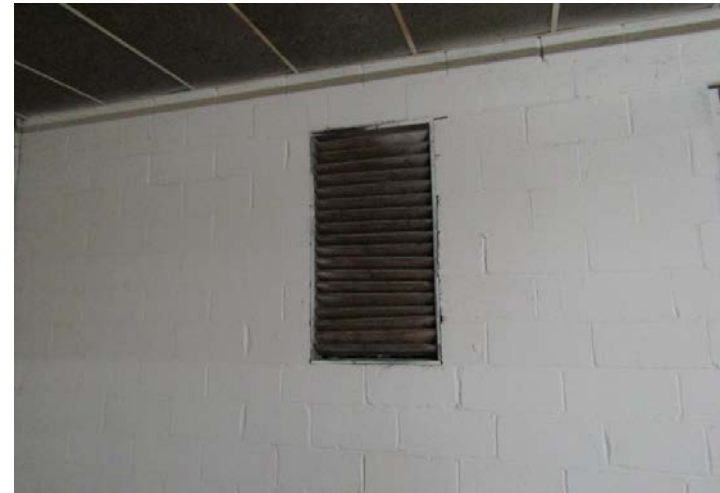
fixed louver

Green ideas: The garage exhaust system serving 1702-04 works off of switches rather than timed intervals (better) or carbon monoxide detectors (best). The switches for the fans were in the "off" position resulting in a safety hazard. The other buildings do not have an exhaust system (likely because they were built earlier and it was not a code requirement) but instead have voids in the block walls that allow for the free exchange of indoor and outdoor air. Portions of these voids have intentionally been blocked, also resulting in a safety hazard. At a minimum, the property should install timers for the operation of the fans and unblock the voids. The property should also consider carbon monoxide detectors to operate the exhaust fans based on the condition of the air rather than timed intervals. This maximizes the quality of the air and minimizes energy consumption.

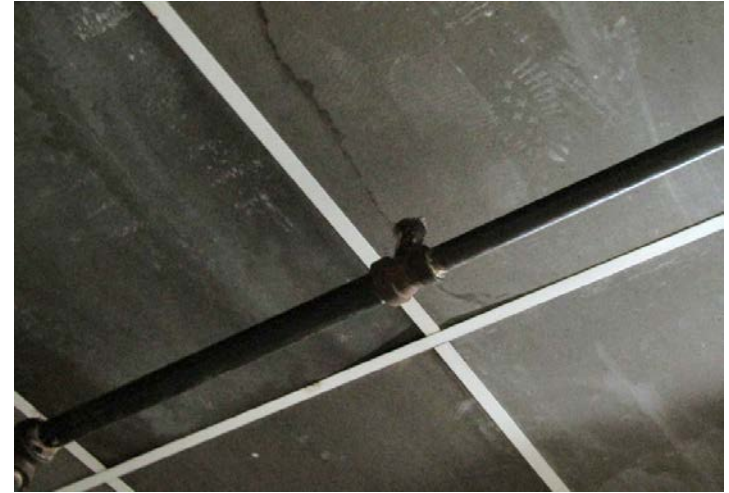
<b>Location:</b>	garages
<b>Area (square feet):</b>	21,000
<b>Head type:</b>	pendent and conventional
<b>Overall condition:</b>	good to fair
<b>Physical condition:</b>	minor rust
<b>Cost (\$/square foot):</b>	\$0.30
<b>Current total cost:</b>	<b>\$6,000</b>
<b>Cost per home:</b>	\$98
<b>Operating expenses:</b>	testing, interim head replacements, painting of pipes, compressor
<b>Cost includes:</b>	replacement of heads only

fire suppression system with conventional head

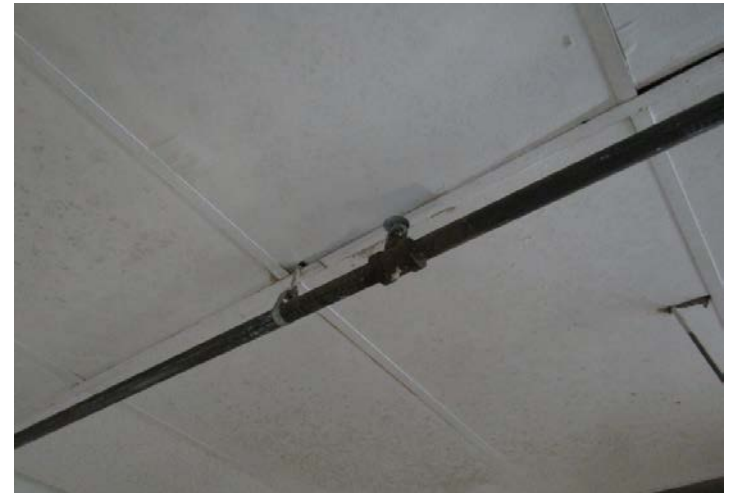
conventional head

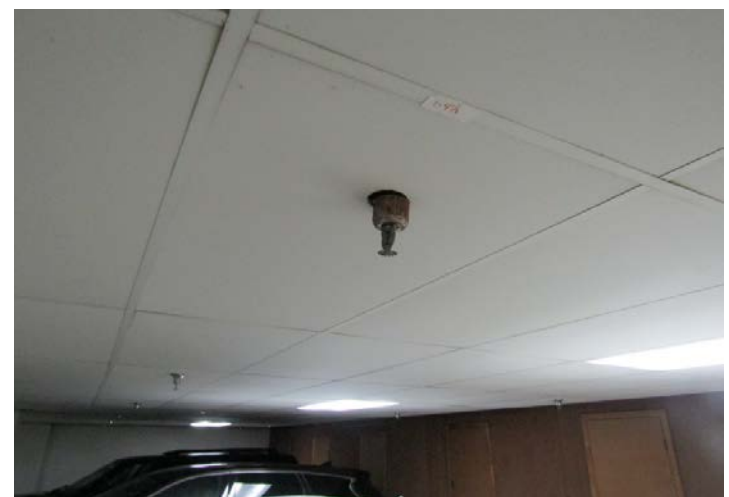
pendent head

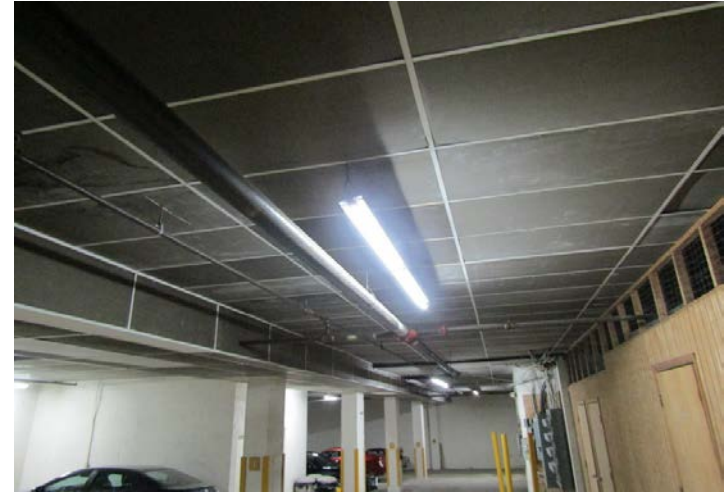
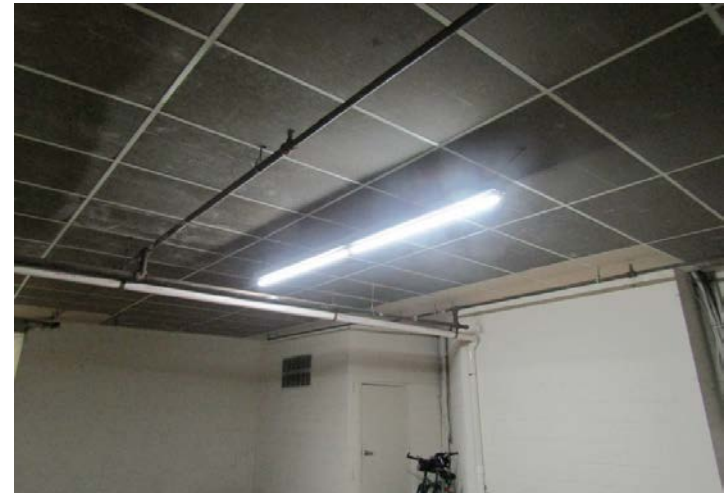
LED garage light

Green ideas: The garage lights operate continuously. Consider installing occupancy sensors to minimize fixture operation or installing light dimmers to minimize energy use during off peak hours. For safety reasons, maintain a minimum light level all times. Our experience indicates properties typically have one out of three lights operate continuously and the remaining two are on sensors. Check with local code for specific requirements. Functional issues may arise with the motion sensors on LED lights. The property may need to put the motion sensors on timers, so the motion sensors only function during non-peak hours of garage use.

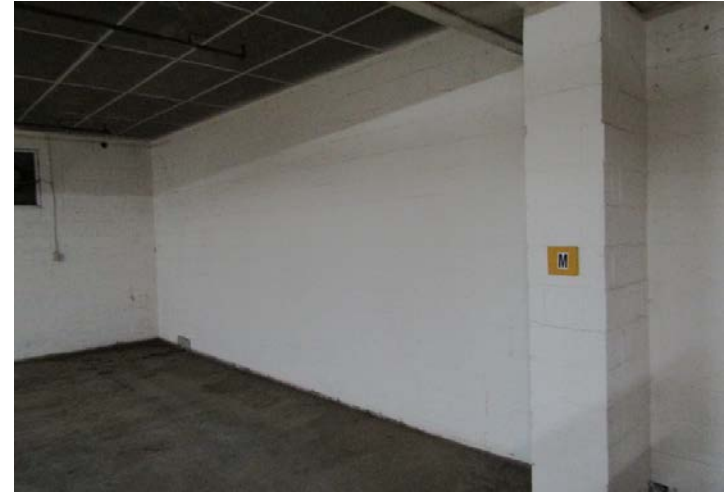
<b>Painted surfaces:</b>	walls and columns
<b>Surface area (square feet):</b>	17,000
<b>Overall condition:</b>	fair
<b>Specific condition:</b>	scuffs and stains
<b>Cost (\$/square foot):</b>	\$0.90
<b>Current total cost:</b>	<b>\$15,000</b>
<b>Cost per home:</b>	\$246
<b>Operating expenses:</b>	cleaning, touch up painting

painting surfaces in garage

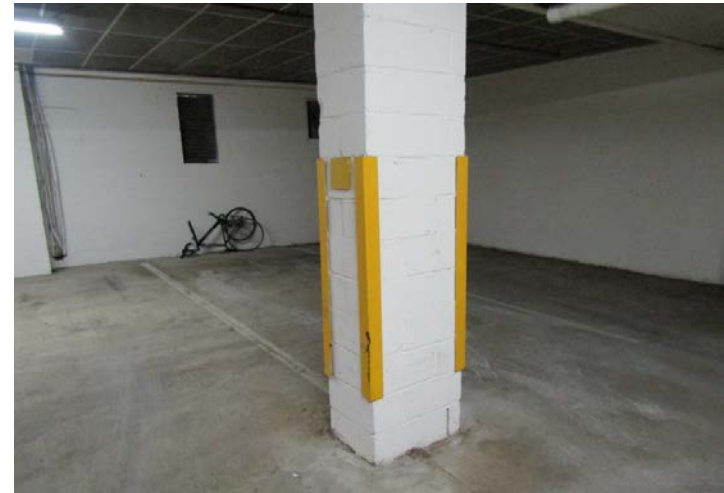
paint on columns

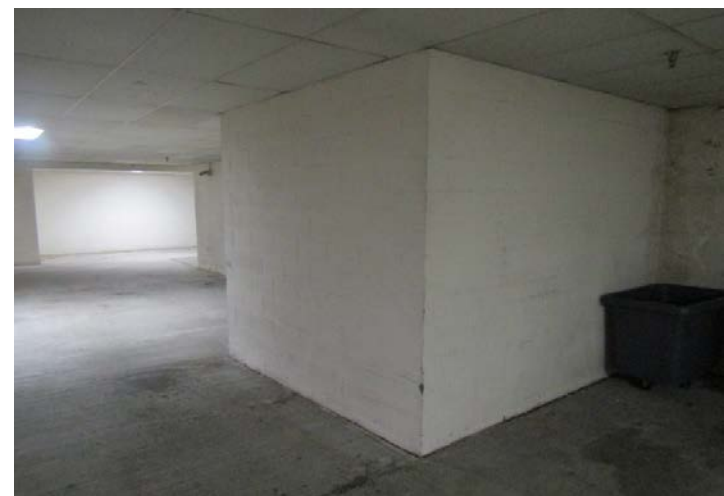
painting surfaces

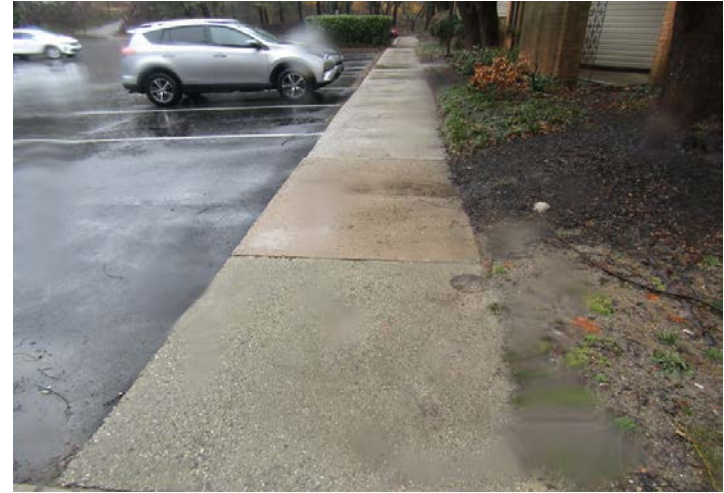
<b>Material:</b>	concrete
<b>Finish:</b>	plain
<b>Overall condition:</b>	good to fair
<b>Specific condition:</b>	cracked sections
<b>Locations:</b>	throughout property
<b>Length (linear feet):</b>	600
<b>Quantity (square feet):</b>	2,600
<b>Per home (square feet):</b>	40
<b>Cost (\$/square foot):</b>	\$8.40
<b>Current total cost (note 1):</b>	<b>\$22,000</b>
<b>Assumptions:</b>	4-inch thick, 3,000 psi replacement concrete with 6x6 - W1.4xW1.4 steel reinforcing mesh
<b>Operating expenses:</b>	marking of trip hazards, interim replacements of deteriorated sections, slab jacking (pumping grout under sections to lift them)

concrete sidewalks

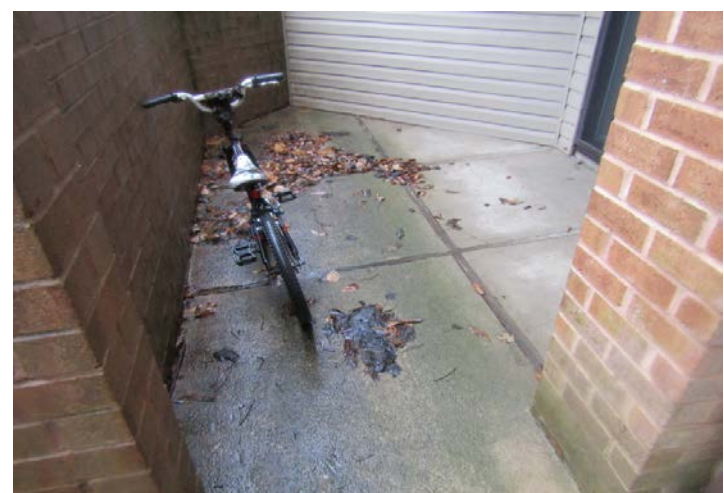
concrete patio

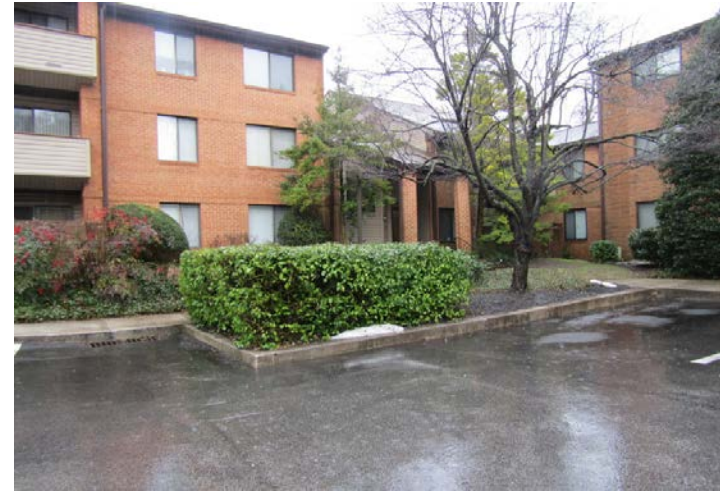
landscape

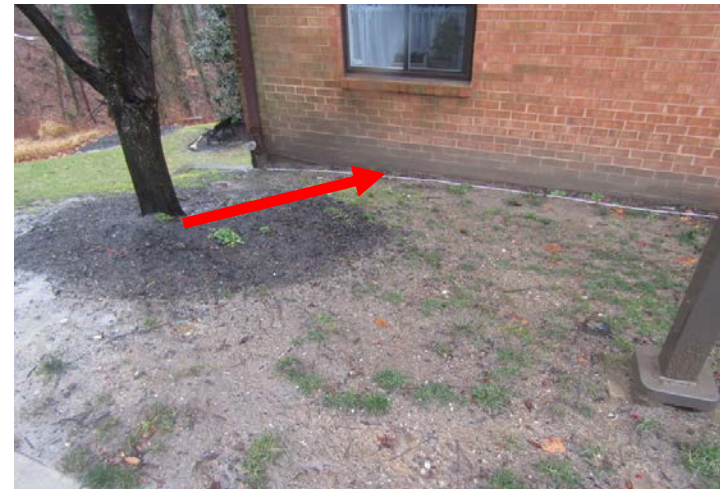
grade pitched towards garage

**Actionable recommendations:** The property experiences active leaks in the garages. We observed locations where the grading is pitched towards the buildings which increases the potential for leaks into the garages. We recommend the property regrade problematic areas as part of the landscape allowance. The grade should pitch a minimum of 2%, or 1/4" per foot, away from the buildings.

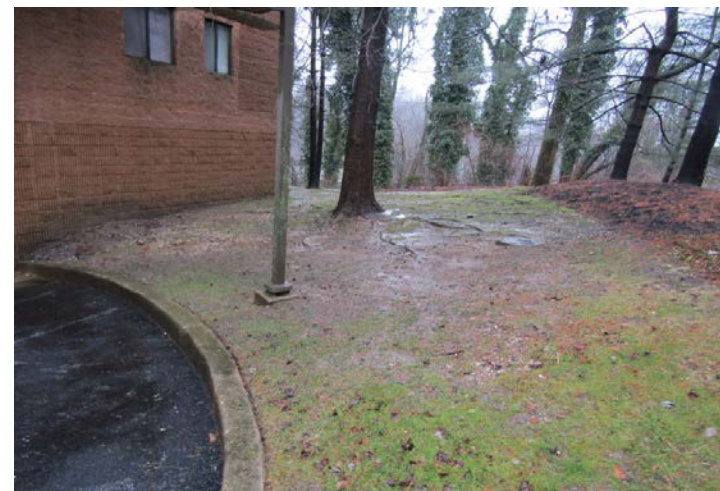
poor grass growth

**Actionable recommendations:** We observed locations of poor grass growth beneath trees throughout the property, resulting in erosion and root exposure. We recommend crown raising (removing lower branches) at these trees to allow sunlight penetration and sustained grass growth.

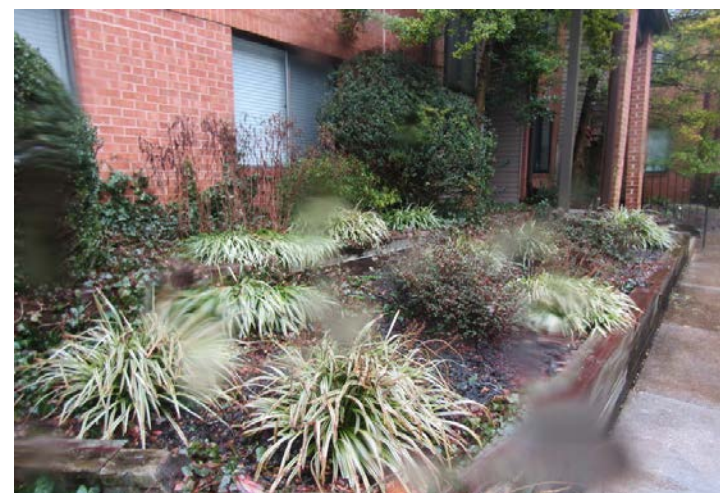
landscape and wood retaining walls

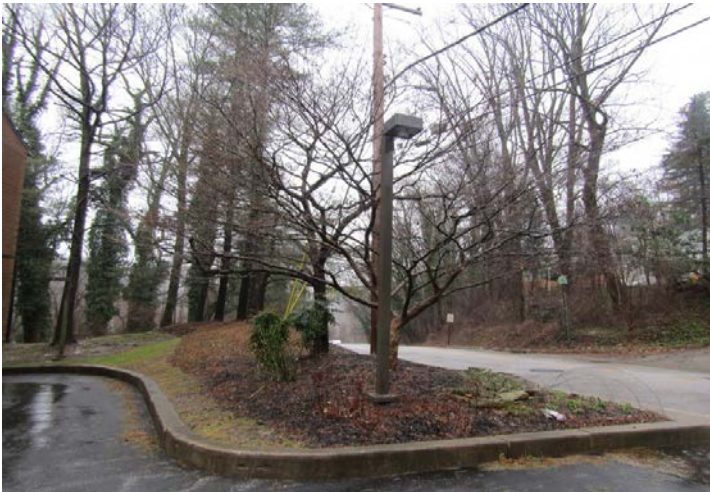
Pole material:	metal
Quantity of poles (each):	10
Pole height (feet):	8
Fixture material:	metal
Quantity of fixtures (each):	13
Overall condition:	good
Specific condition:	no visible deterioration
Locations:	parking area and buildings
Average cost (\$/each):	\$2,000
Current total cost:	\$20,000
Cost per home:	\$328
Assumptions:	reuse of existing subterranean electrical supply wiring and footings
Operating expenses:	painting, bulb replacement

metal light pole with metal light fixture

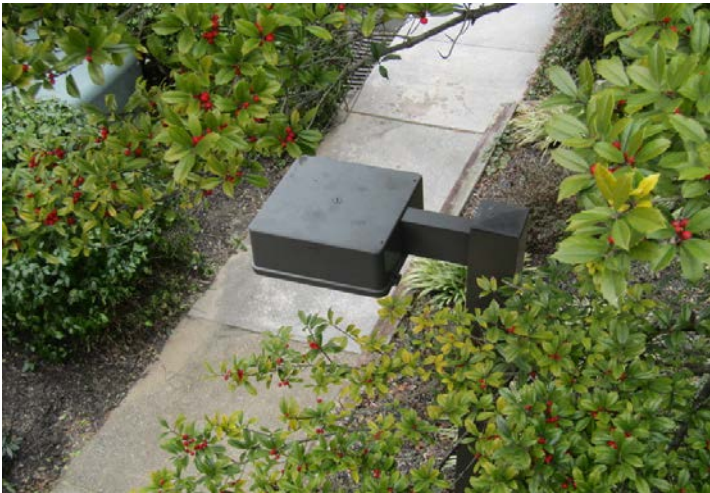
light fixture atop pole

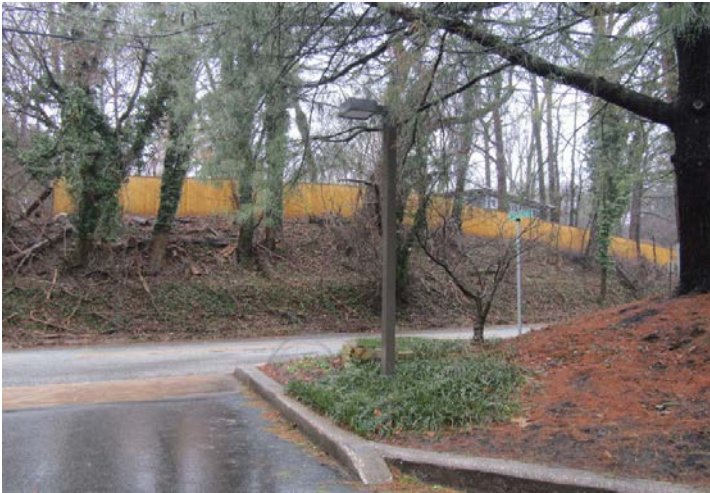
light pole and fixture

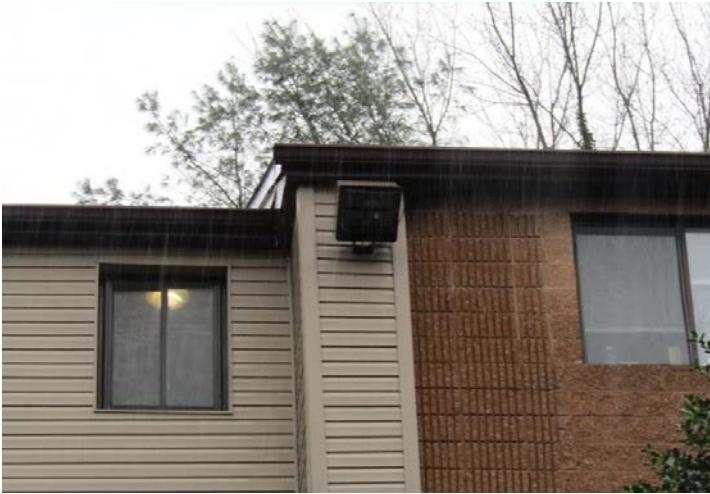
light fixture on building

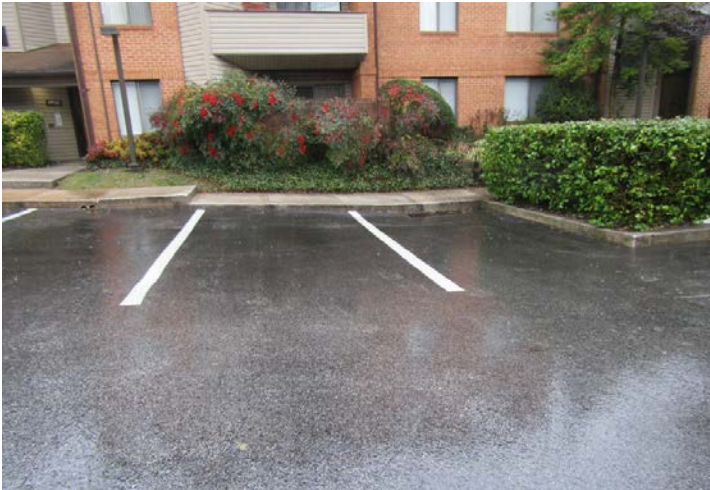
Material:	asphalt
Location:	parking areas
Overall condition:	good
Specific condition:	no visible deterioration
Typical traffic type:	residential vehicles and garbage trucks
Quantity (square yards):	2,500
Per home (square yards):	41
Quantity of catch basins:	3
Square yards of pavement per catch basin:	800 (reasonable amount of pavement per drain)
Repaving method:	replacement
Cost (\$/square yard):	\$43
Current total cost:	\$108,000
Cost per home:	\$1,770
Operating expenses:	crack repairing, patching and striping
Anticipated costs:	remove pavement, regrade & augment base install 4 inches of new pavement repairs to catch basins (3 each) stripe parking areas

asphalt pavement at parking areas

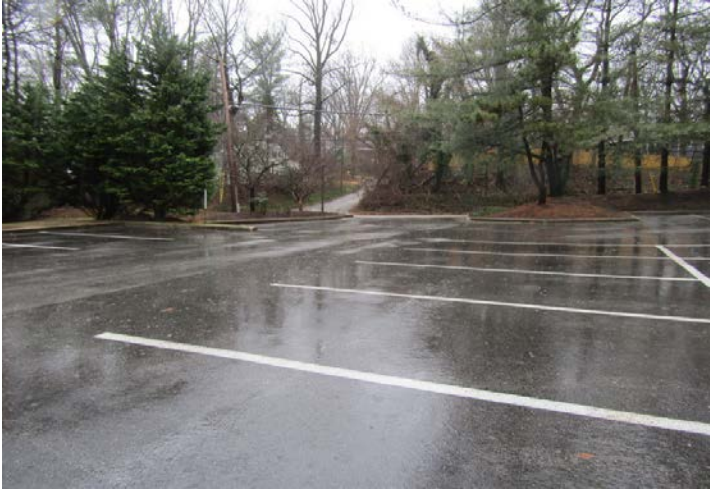
pavement overview

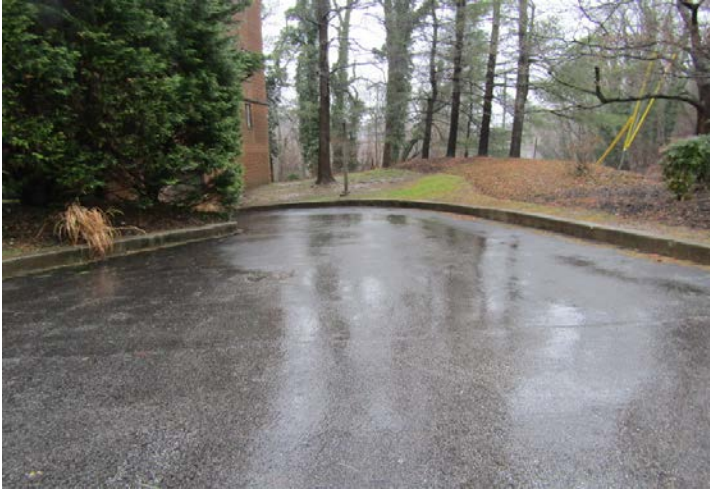
pavement in good condition

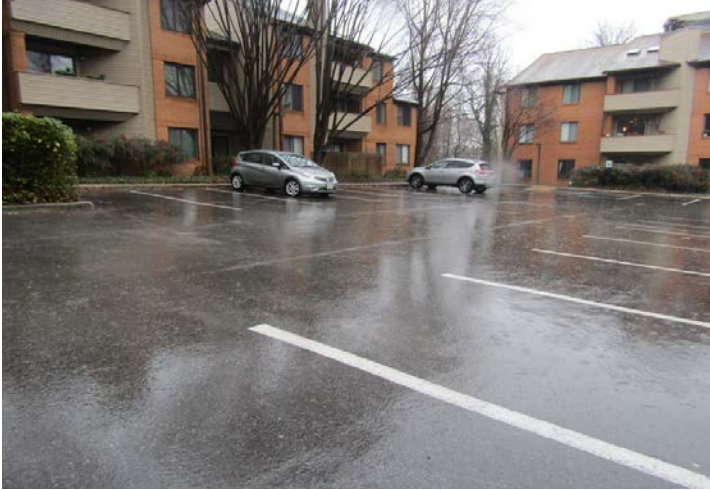
asphalt pavement
